Seismic Retrofitting of CD Hospital in Srinagar Kashmir

5.1 Government Chest Disease Hospital Dalgate, Srinagar

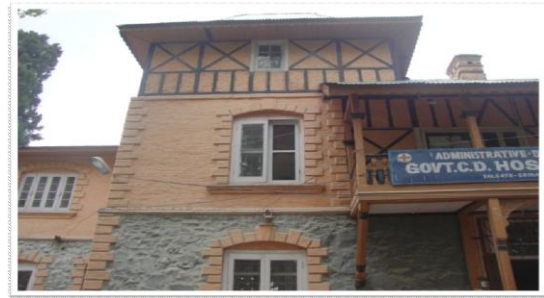
Figure 1: View of Govt. CD Hospital, Srinagar Kashmir

The hospital is mainly comprised of blocks like OPD ward, Emergency section, Surgery block, Isolation block etc. The blocks seem to be more than 50 years old and have become obsolete during the course of time. The administrative block is some what fine compared to other blocks of the hospital as shown in figure 1

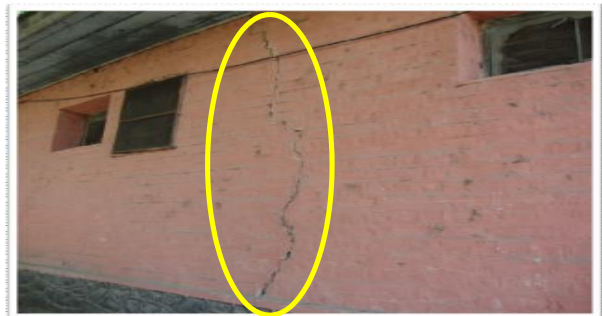
Figure 2: G3 Crack in wall

In the below table 1 dimensions of the wall are given. A large vertical crack about 5m is clearly visible. The wall comes under the category of grade 3 hence maximum sagging has taken place in the mid way section of the wall. The h/t and l/t ratios are also given in the table 1

Cracks come under the 3rd grade of cracks i.e. its diameter is 5-10 mm. Cracks are located in the middle of the wall and are connected from the roof to the plinth. The walls are thought to have behaved like a permanent beam since it was erected on the corners and other walls, which is why a high slope has occurred in the middle part of the wall.

- A V notch is to be made through the crack and then cleaned with wire brush.
- The fine and the loose particles inside the crack need to be removed by jet of water.
- A masonry surface 200mm wide is to be prepared on the both faces of the wall. The plaster is removed and

ferrocement splices are added in the crack. The joints are raked upto a depth of 12mm and cleansed with water.

- The crack is then filled with 1:3 cement mortar with sufficient mortar to move as far as possible.
- Insert 150mm wide gauge galvanized mesh with 100mm ling wire nails at spacing not greater than 300mm in a lurched manner.
- The gap between mesh and unplastered wall should be 10mm.
- The mesh is to be plastered with 12mm coats of 1:3 cement plaster.
- Curing for a period of 15 days.

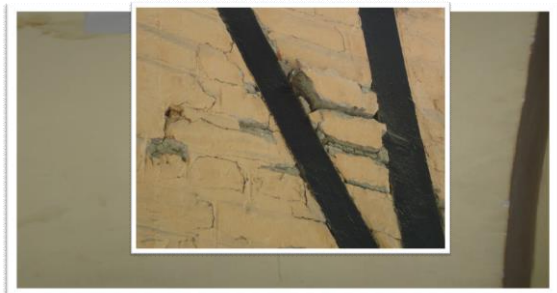
Figure 3: Distress fine crack

The type of cracks fall under Grade 1. These cracks are usually less than 1mm wide which is why they are large and measured in length as shown in Fig. 3.

The reason for this crack is that the walls are fixed. with walls adjacent to the corners. When an earthquake occurs it is associated with walls which is why the part that is not in the corner will move too much and cause a vertical crack near the wall section. If the wall is too high an earthquake can create vertical cracks and a horizontal surface

- A V notch is to be made along the length of the crack.
- The crack is to be cleaned with a wire brush
- The gap formed is to be filled with 1:3 cement mortar.
- The restored part is finished with the surrounding wall surface
- Cure for 7 days.

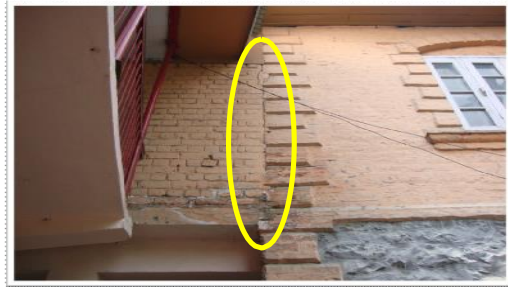
Figure 4: Possibility of Pounding

A small corner corner is built next to the old part of the building. A member is provided to separate the two buildings but a space to avoid beatings has not been provided. The roof level of the newly constructed section was on the walls of the old part, under such conditions a strong blow could cause extensive damage during an earthquake.

The most likely remediation step is to remove the vertical brick wall between the two internal structures in order to overcome

the impact force. In order to take precautionary measures, more than one brick should not be removed and the integrity of the structure maintained.

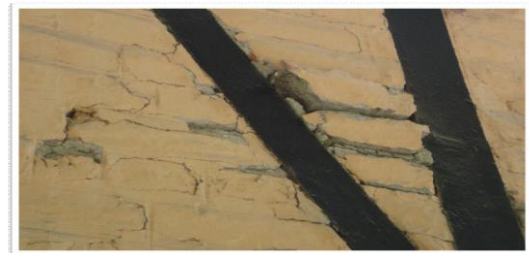
Figure 5: Damage to infill walls

There were numerous places where infill dhajji walls were damaged. The infill bricks had come out at many places as shown fig 5. Damage to these infill dhajji walls is because of possible energy dissipation during an event of an earth quake.

The damaged infill should be replaced new infill bricks.
