Structural Problems Occurring in Reinforced Concrete Drinking Water Tanks and Water Loss Prevention Methods

Dr. Ayşe Yeter GÜNAL¹, and Kadir Başar²

¹ Assistant Professor, Department of Civil Engineering, Faculty of Engineering, Gaziantep University, Türkiye

² Student, Department of Civil Engineering, Faculty of Engineering, Gaziantep University, Türkiye

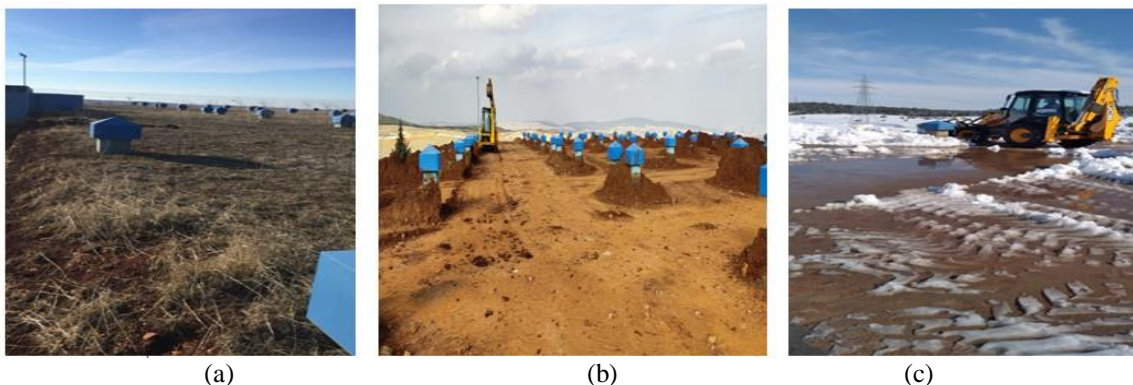
Figure 2: (a) Water Tank Roof (b) Removing Soil From Roof (c) Cleaning The Roof

Reinforced Concrete Reservoir Roof Waterproofing; Prismatic reinforced concrete water reservoirs are made as recessed according to their location on the ground. This type of water reservoir is covered with soil up to 1 meter above the reservoir to prevent the drinking water in the tank from being affected by the external environment. For this reason, it is the soil at a height of 1.00 m that keeps the rain, hail or snow water on the roof of the reservoir as shown [Figure 2](#). It usually causes further infiltration downwards. Water infiltration into the concrete continues to progress over time from the base slab to the shear concrete and foundation. Also due to the lack of proper settling and the fact that the air temperature is different, water can seep into the structural elements through pores or slight cracks, no matter how small they may be. Therefore, waterproofing to prevent water infiltration becomes indispensable for the life and durability of the structure. In water tanks where maintenance and repair is carried out, it is necessary to remove the soil cover on the tank as a priority. Then the surface must be cleaned for application.

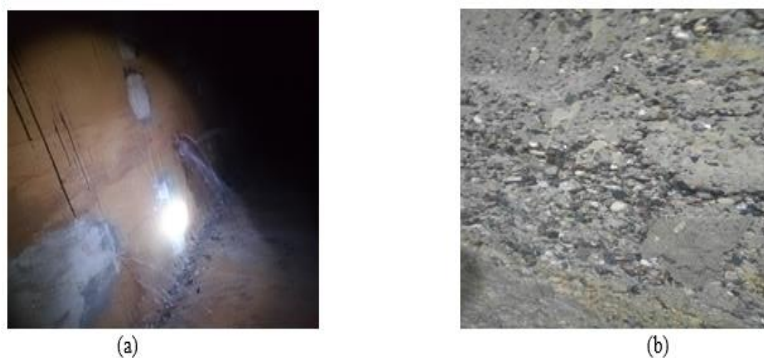
Figure 5: (a) Leakage Between The Pores of The Water Tank, (b) The Surface of The Concrete In The Water Tank

Cement based adhesion and corrosion control mortars containing high quality cements, silica fillers, silica fume additives and performance enhancing chemicals were used to repair tired holes in reinforced concrete walls and deformed exposed concrete surfaces in the tank. (see Figure 05)

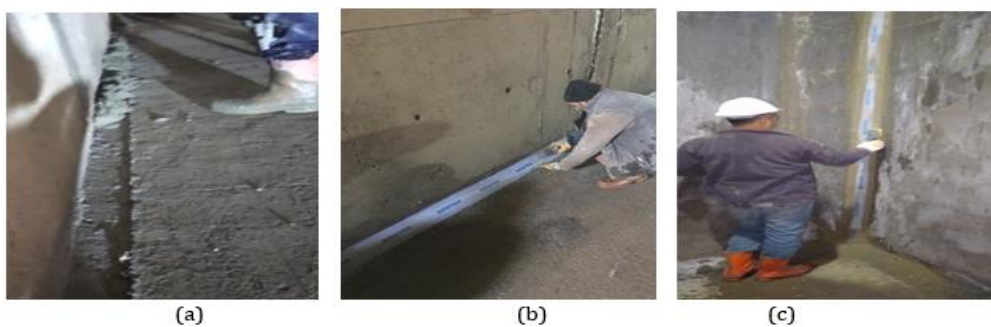
In the connection of two reinforced concrete walls and the connection of a reinforced concrete wall and a foundation, there is more reinforcement in terms of strength. For this reason, the concrete may not settle completely and create a gap and this may cause water loss. In order to minimize water

Figure 6: (a) Wall and Base Junction of The Water Tank, (b) Horizontal Chamfer Application, (c) Vertical Chamfer Application

loss, corner chamfers were made as 10x10 cm with cement-based fiber and polymer reinforced, high stability gross concrete repair mortar at the corner joints. (see Figure 6) Then, a polypropylene-based, polyurethane film-reinforced, waterproof, elastic 12cm joint tape will be glued on it.

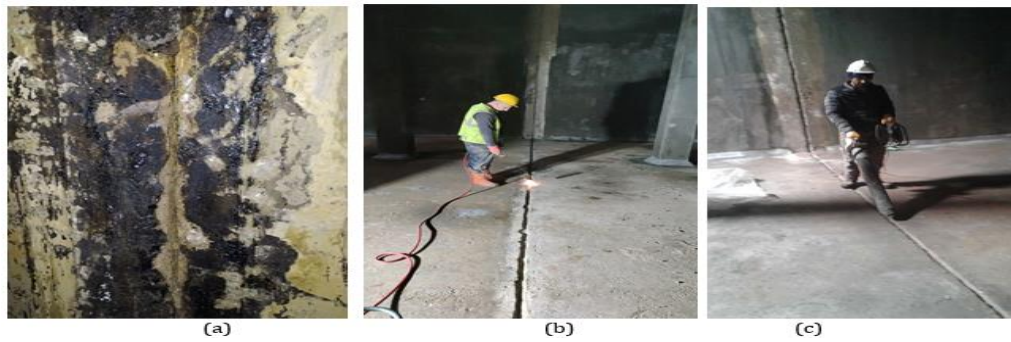
The fact that the water tank has been subjected to ground settlements over time, the pressure of the water in the tank

and the earthquake loads have caused deformations and separations between the dilatation joints over time.

Figure 7: (a) Initial Condition Dilatation Joint, (b) Cleaning The Dilatation Joint With Blowtorch, (c) Cleaning The Dilatation Joint With Air Compressor

Therefore, it was foreseen that the dilatation joints should be renewed. Stage 1 is to dismantle the existing dilatation joint and clean the joint gap (see Figure 7). In the dilatation joint cleaning process, after the old insulation material is removed, the joint cavity is cleaned with air, then the old insulation is burned with a blowtorch to destroy small pieces of insulation. Then, after applying

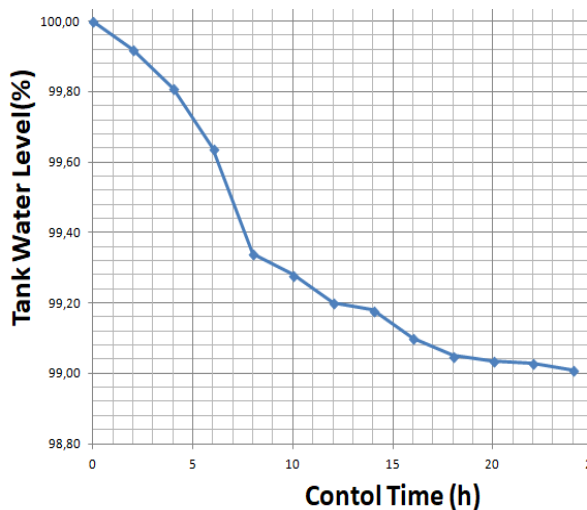
As a result of the research, Leak tightness tests were carried out on water tanks with a capacity of 15,000 cubic meters, the maintenance and repair of which were carried out by GASKİ. International standards (ACI, BSI) have been taken into account. The water tank was filled with water, ensuring that the water tank leaked 0.1 percent in any 24-hour period (see Figure 10).

Figure 10: Control Water Tank 24-hour period

The water tanks, whose waterproofing works were completed by Water and Sewerage Administration, met the standards in the tightness test.
